Volume 17 Issue 1 Year: 2020

The conservation and restoration performances under Seljuk Architectural Patronage

Tülay Karadayı Yenice¹

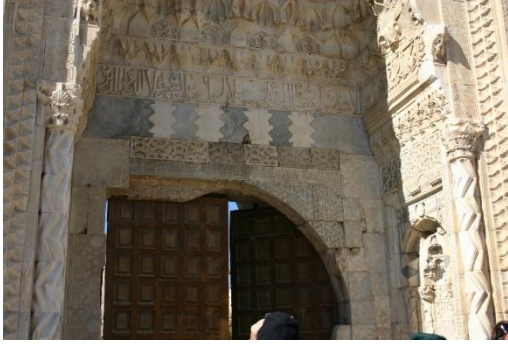
Figure 3. The Flat Camber Arch and The Inscription

The faces on both sides of the 2.75 meters arch opening, are decorated with a pattern of geometric composition are partly imbalanced. At the level of the keystone of the arch, there is another tectonic belt, which is filtered through stylized floral motifs, with a booklet strip, and a deeply carved geometric pattern filled with floral motifs. The upper level consists of a flat camber arch made of two-coloured roller stones and an inscription (Figure 3).

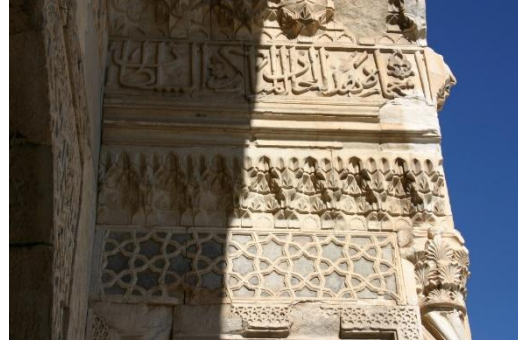
Figure 4. The Inscription details

After inscription this strip, there is a bracelet with a muqarnas covering the door. In this façade layout, the arched opening beneath the flat of camber arch, as can be understood from the restoration tablet, gained this appearance after the restoration. During this restoration, the original style of the door around the door opening we know that the sound of the originals are preserved, using them, if necessary, by adding new additions around the door cavity, has been restored in the form of a pointed arched passage. In accordance with the tradition of the restoration of this restoration, it was placed on the new belt. (Figure 4).
